Norstar/Companion  
Alarm & Event Code Manual

August 1994

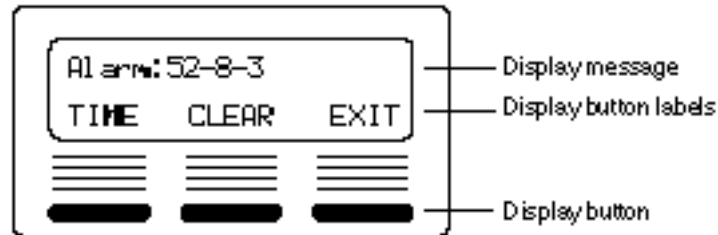
Alarm codes appear at the alarm telephone (if one has been identified in Administration programming) and in the System Test Log, the System Event log and the Network log during a Maintenance session. The following figure shows an alarm code as it appears on a Norstar alarm telephone display.

In addition to the alarm code, a series of digits may appear after hyphens to further define the appropriate port number or Trunk Cartridge number.
